**Survey and Documentation Services
12th Street Landfill Site
Wilmington, Delaware**

Subject: Contract 00151122, Survey and Documentation
Services, 12th Street Landfill Site, Wilmington,
Delaware (Your P.O. #13047)

**FIELD REPORT
EXISTING STRUCTURAL CONDITIONS**

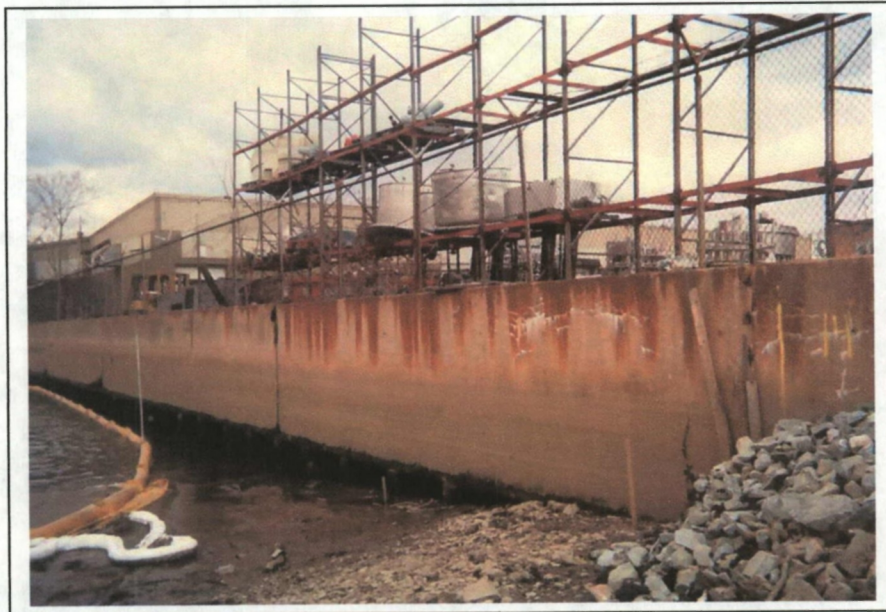
Photo Id: No. 1
Date 3/14/01

Overview of the west face of the retaining wall looking north

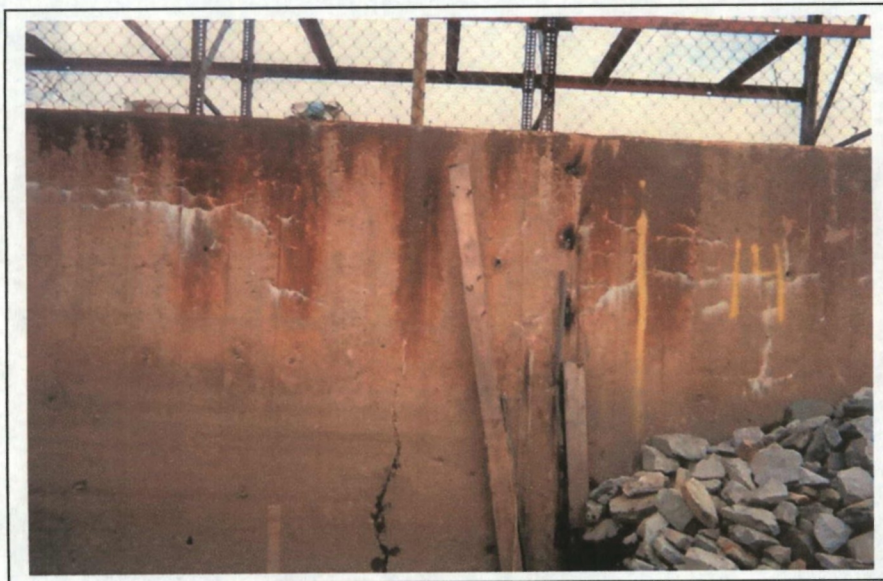
Photo Id: No. 2
Date 3/14/01

Vertical crack that extends the entire height of the wall. Located 16 ft from the north end of the wall. ~ 7'6" high, 1/4" thick

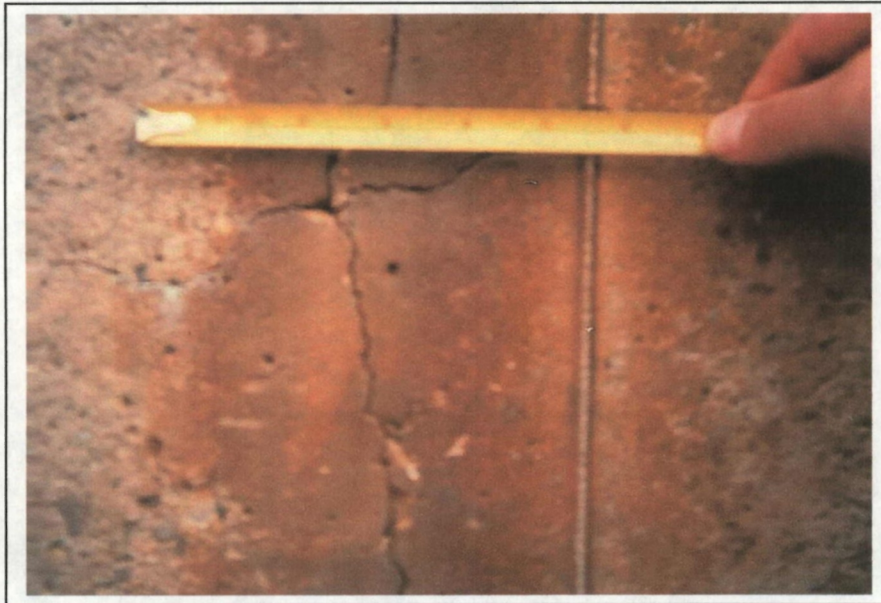
Photo Id: No. 3

Close up view of the upper portion of the 7/6" vertical crack. Rule used for scale. Two horizontal hairline cracks ~ 6" long

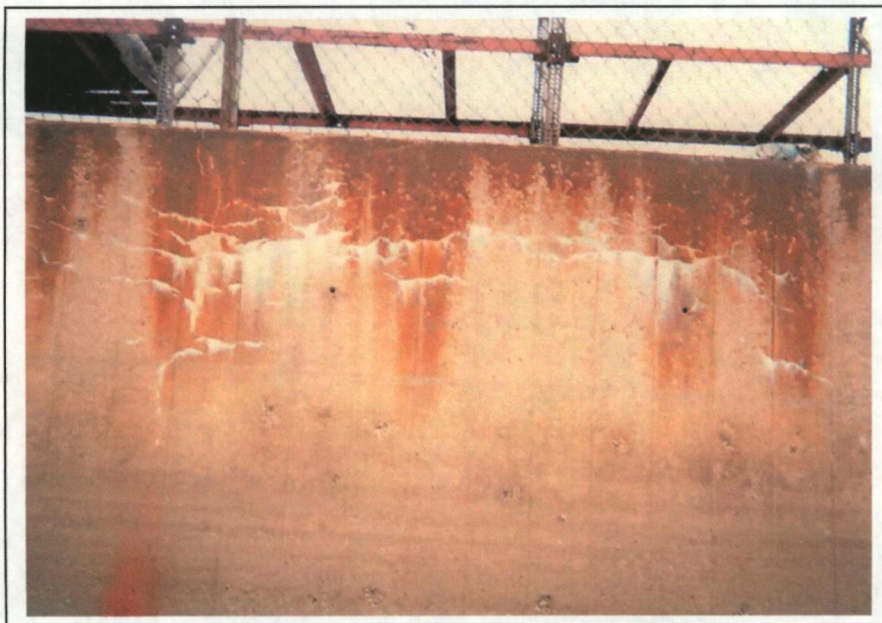
Photo Id: No. 4

Discoloration – rust/lime corrosion of the wall

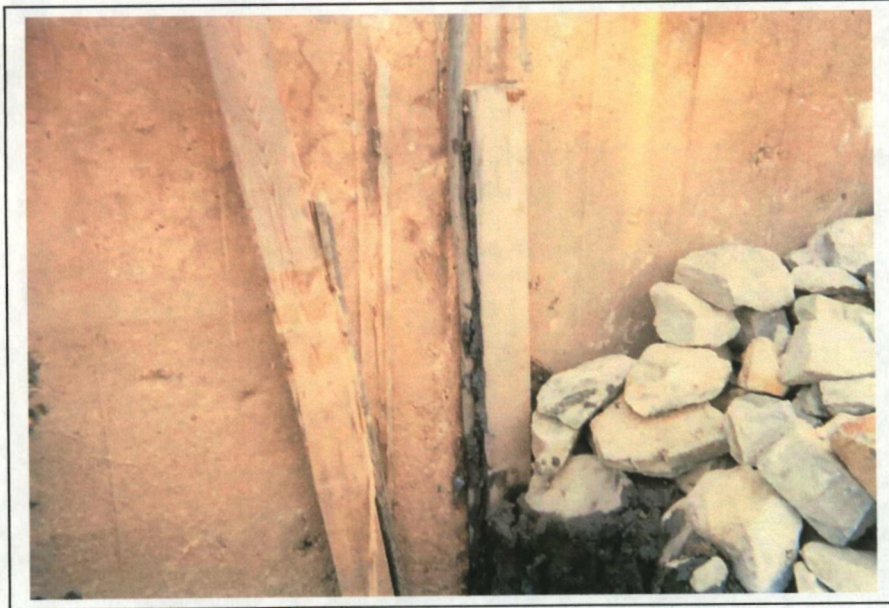
Photo Id: No. 5

Location where the first pile tied into the retaining wall

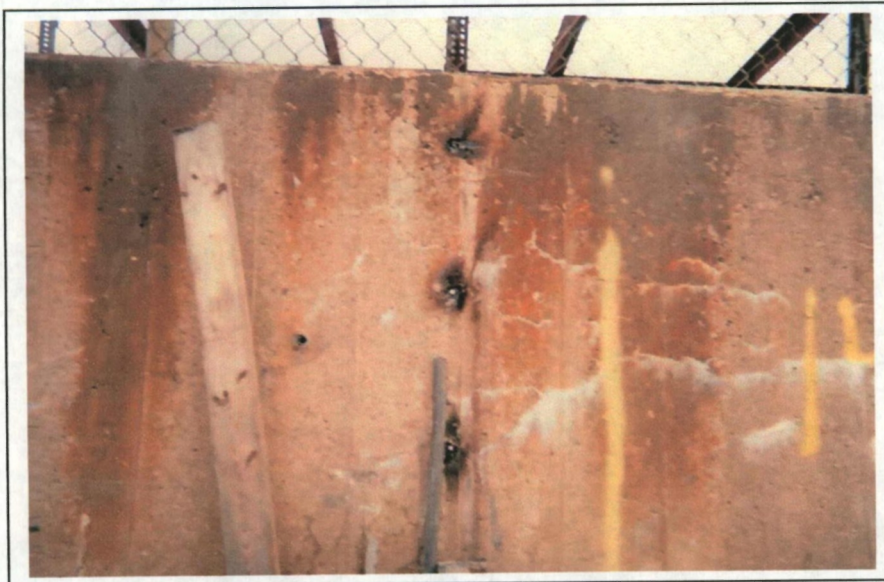
Photo Id: No. 6

Left over burn marks at the points where the pile was bolted to the retaining wall

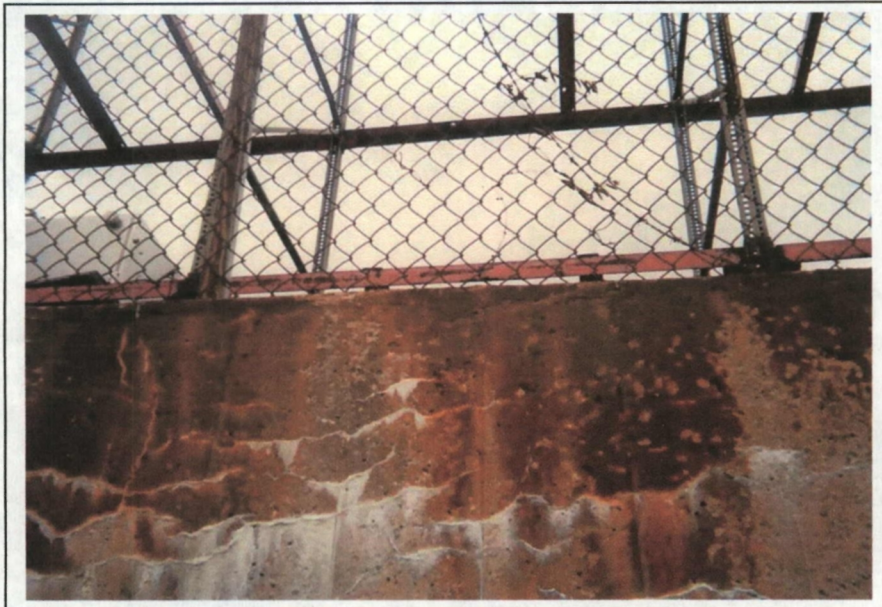
Photo Id: No. 7

Horizontal H.L. crack extending north from 7'6" crack ~ 8' long, located 1" from top of the wall

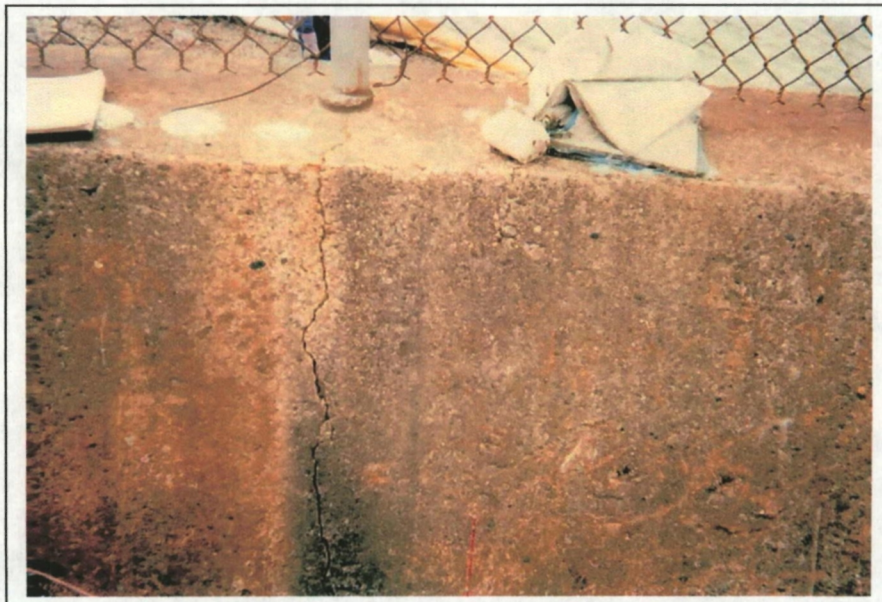
Photo Id: No. 8

Vertical crack extending across the top of the retaining wall and continuing down the back side. Located at the same point as the 7'6" crack on the reverse side

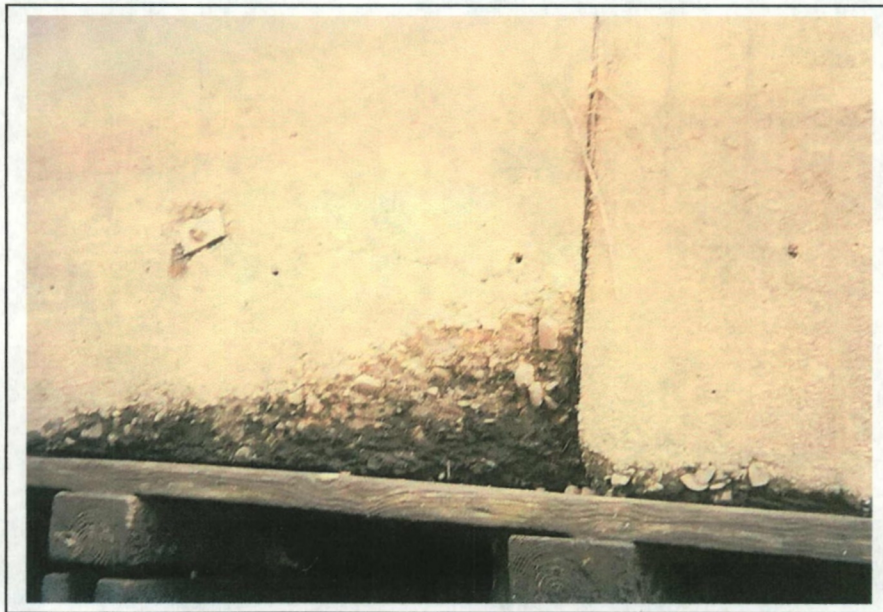
Photo Id: No. 9

Separation joint 2 and missing concrete at the base of the retaining wall

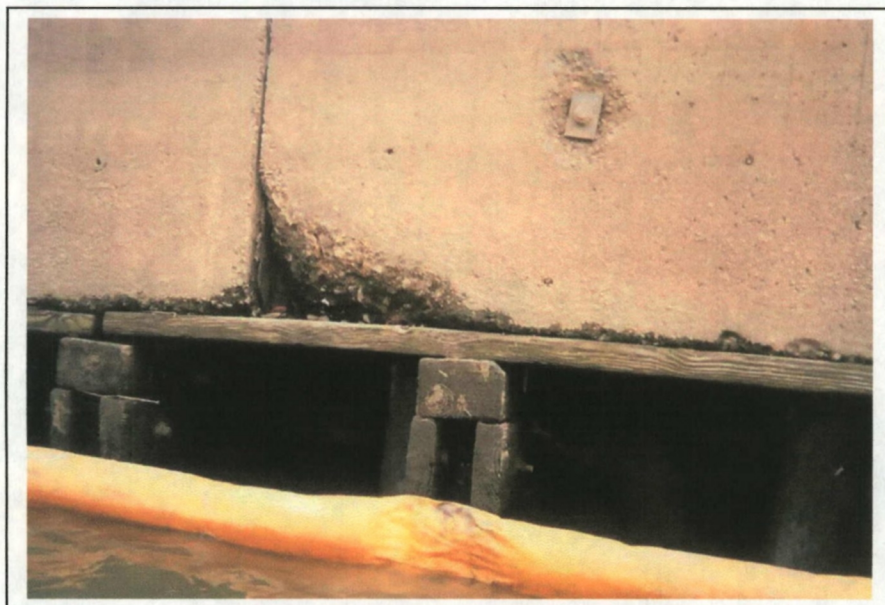
Photo Id: No. 10

Separation joint 3 and missing concrete at the base of the retaining wall

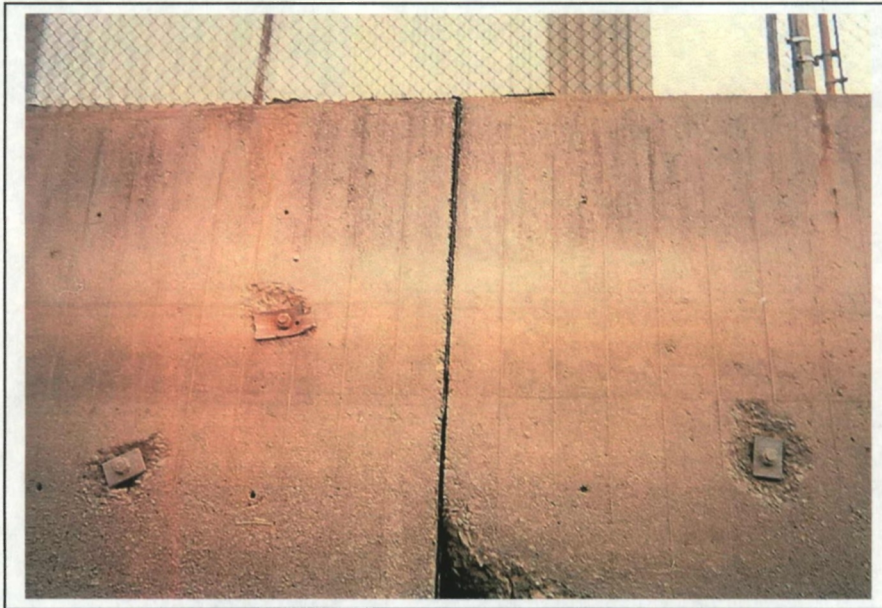
Photo Id: No. 11

Separation joint 3 and missing concrete around existing bolt locations

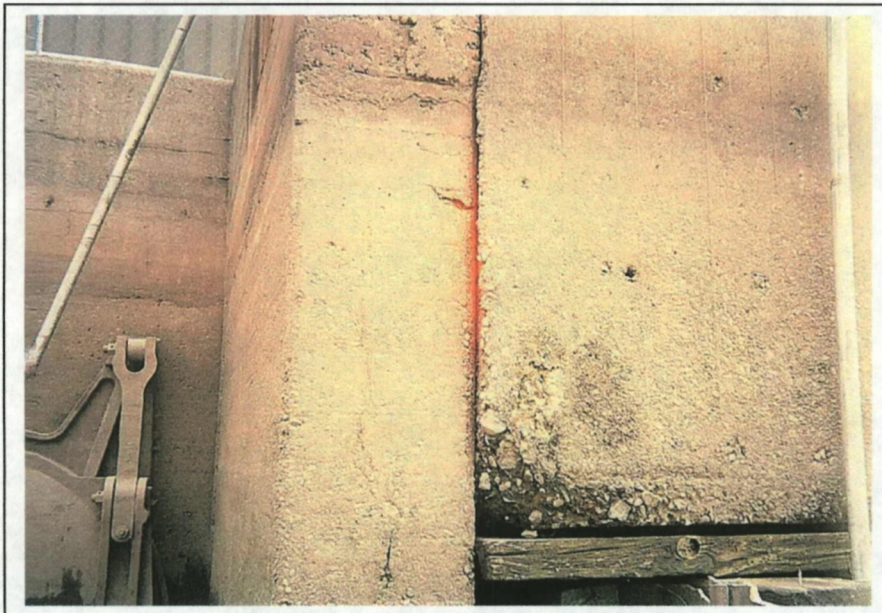
Photo Id: No. 12

Large vertical separation at the north end of the retaining wall and missing concrete at the base of the wall.
Small H.L. cracks also noted

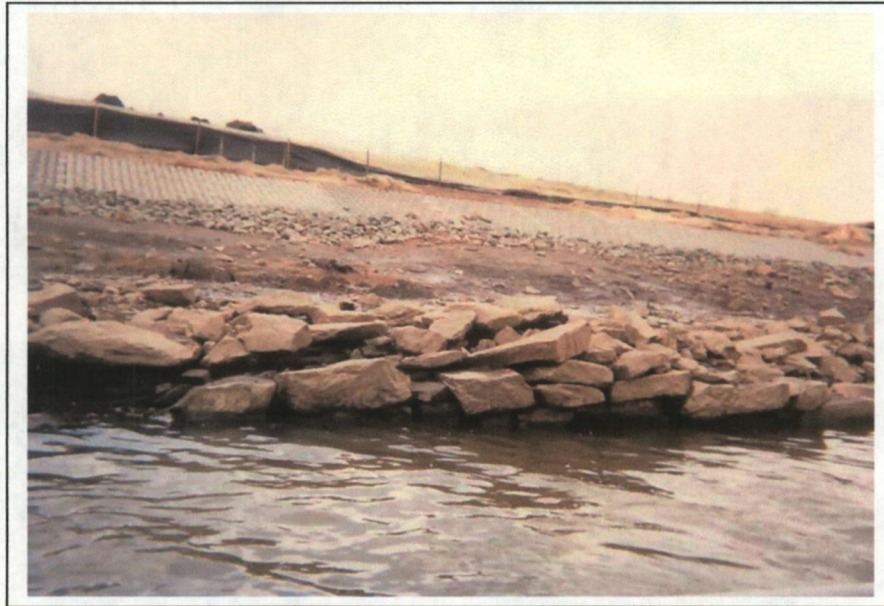
Photo Id: No. 1
Date 3/14/01

Overview of the west face of the old stone wall (Structure #2)

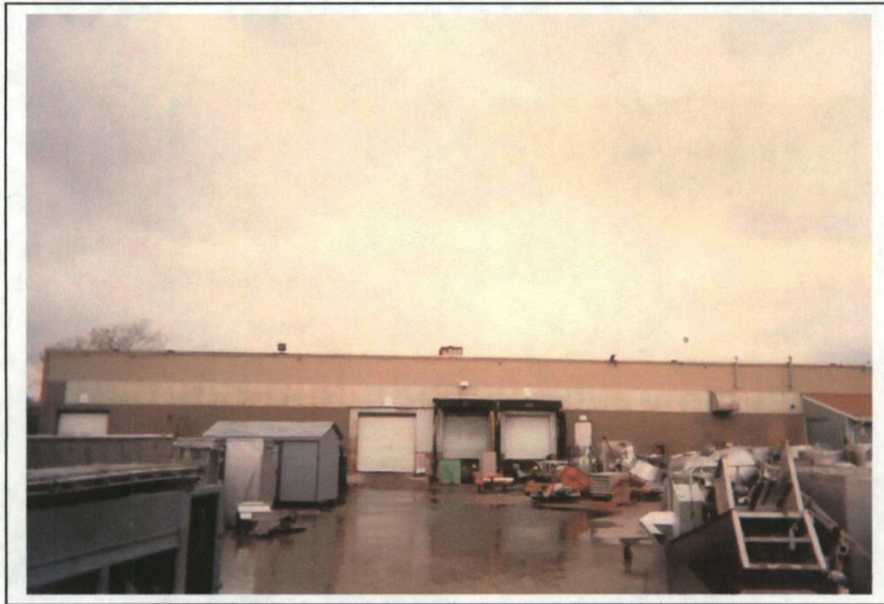
Photo Id: No. 1
Date 3/14/01

Overview of the warehouse (south face)

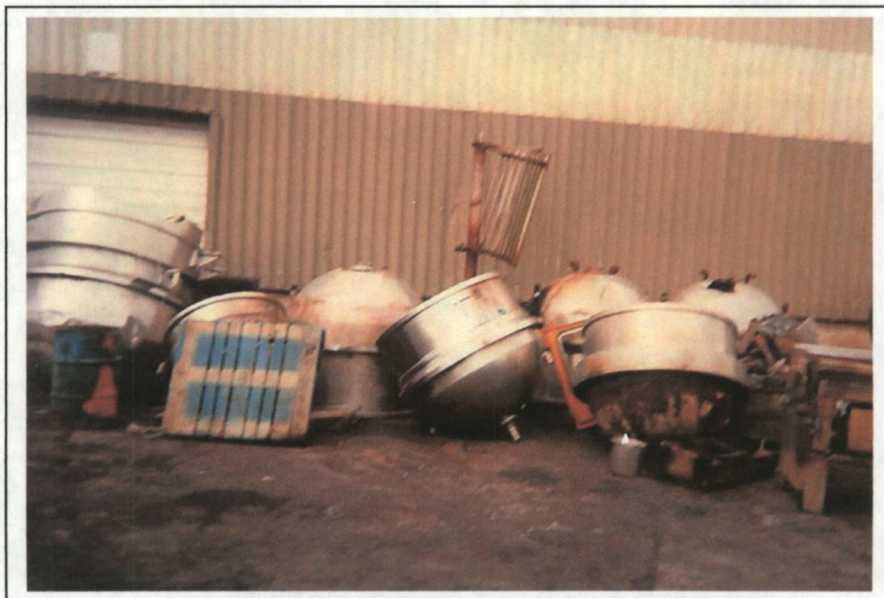
Photo Id: No. 2
Date 3/14/01

Obstructions in the area of garage door #1

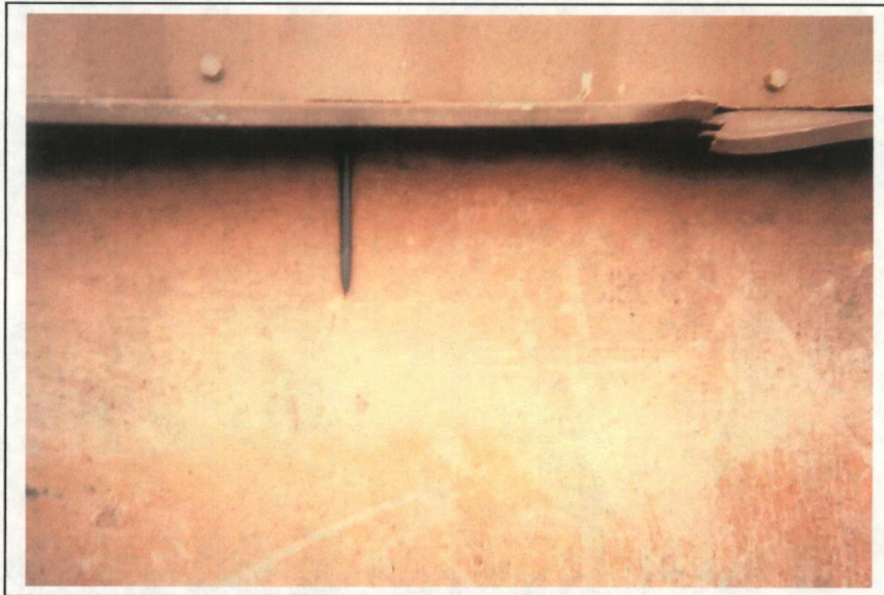
Photo Id: No. 3

H.L. ~2 ft long extending from siding and 10 ft west of garage door #2 (pencil for scale)

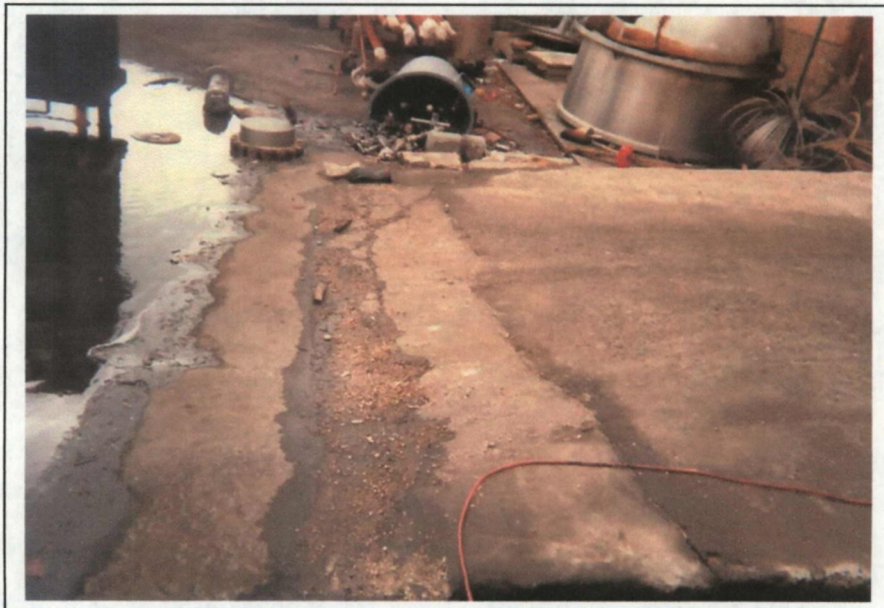
Photo Id: No. 4

Horizontal cracks extend the entire length of the garage ramp in front of garage door #2

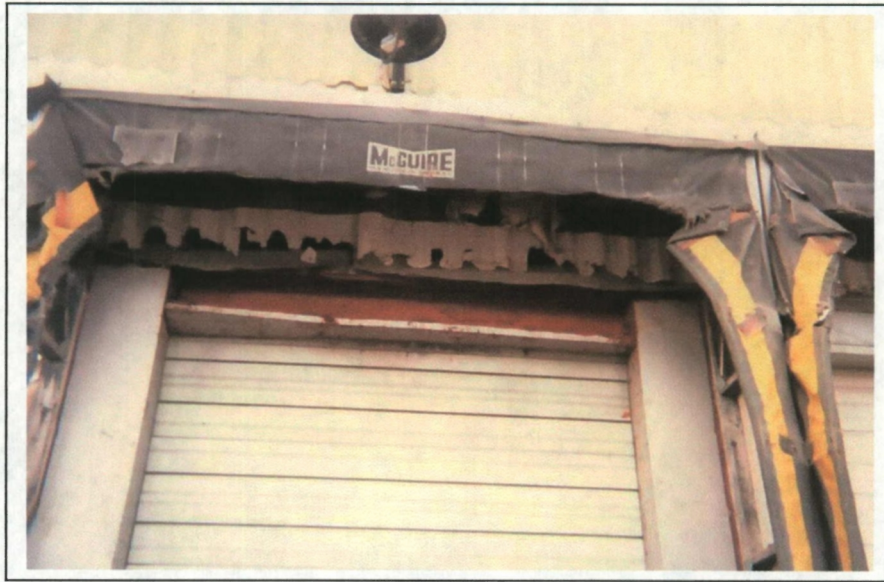
Photo Id: No. 5

Siding damage above garage door #3

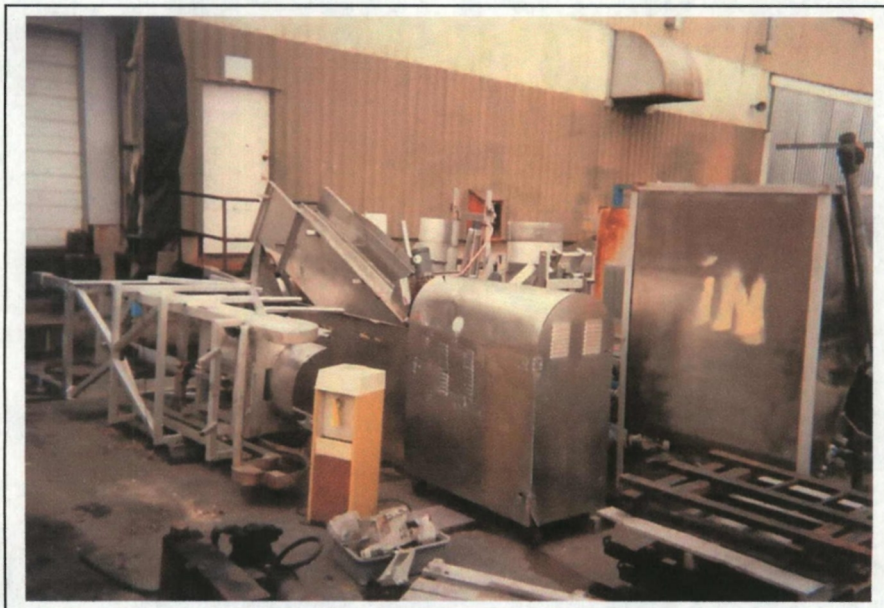
Photo Id: No. 6

Obstructions east of garage door #4

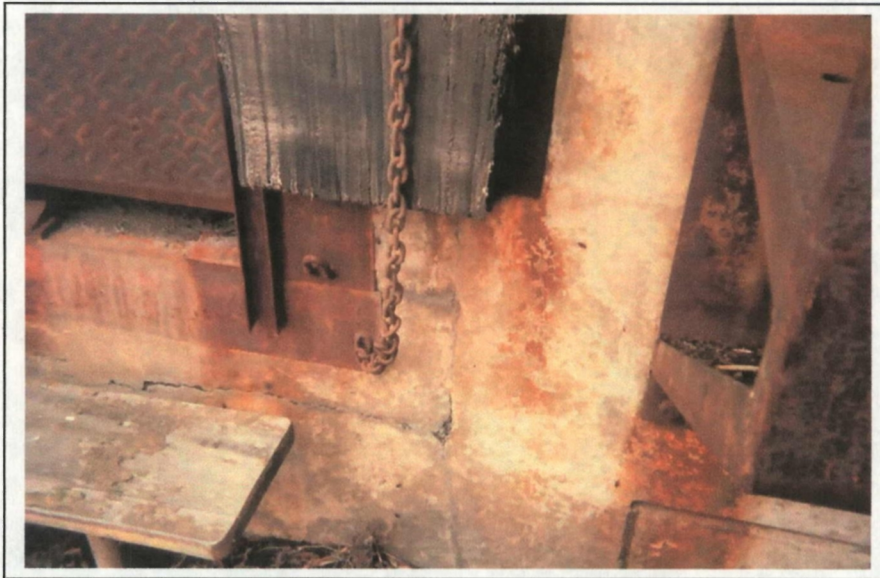
Photo Id: No. 7

Step crack extending from the east corner of garage door #4

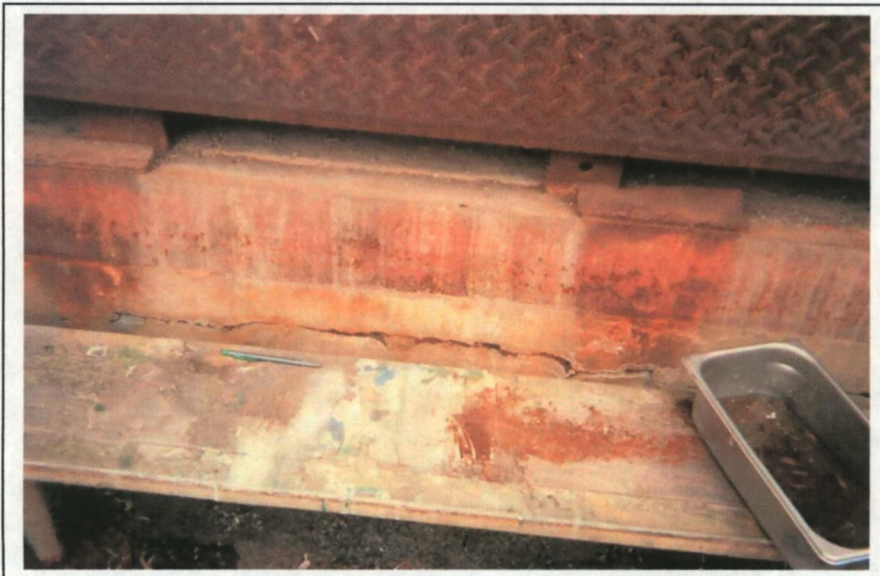
Photo Id: No. 8

Horizontal crack below garage door #4 ~7 ft long and 1/8" thick

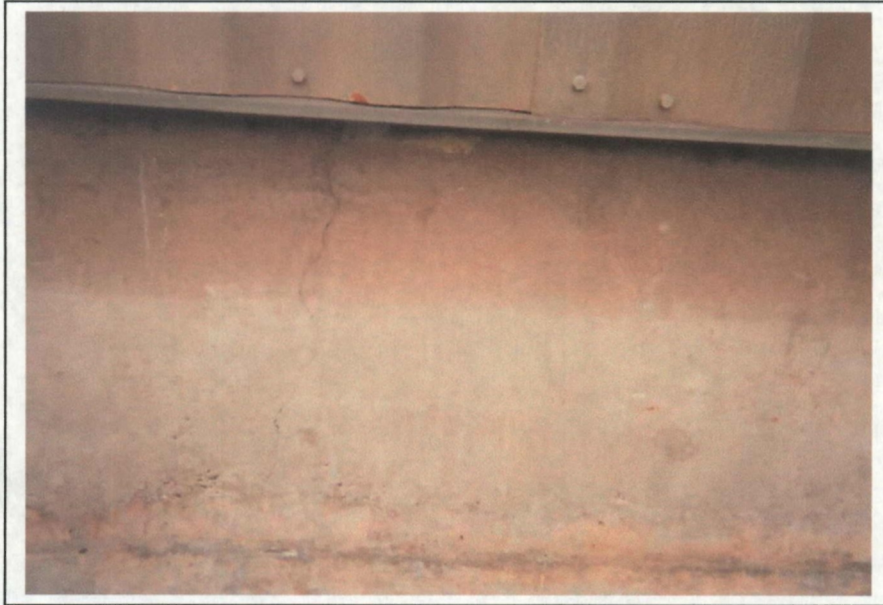
Photo Id: No. 9

Vertical hairline crack extending from the siding ~ 1½ ft long and 5 ft east of the stairs

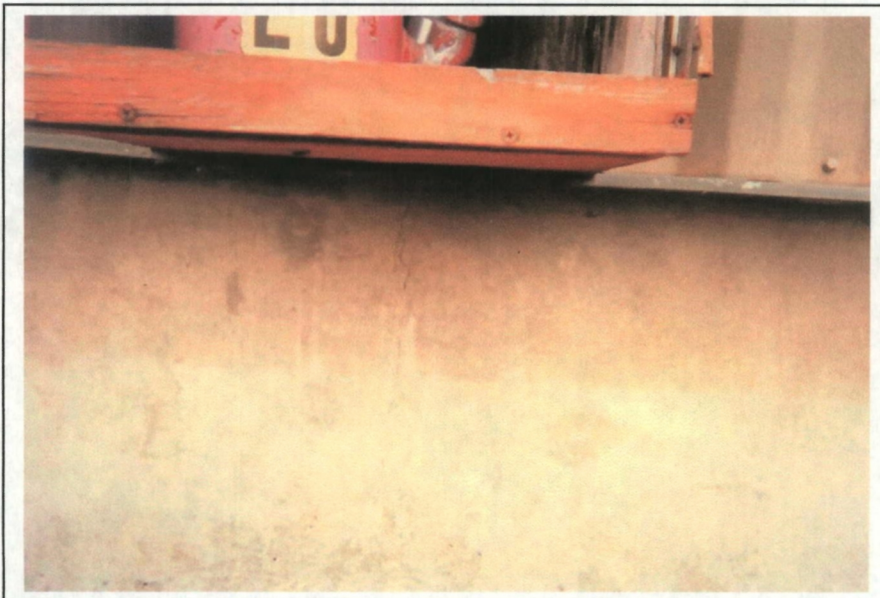
Photo Id: No. 10

Vertical hairline crack extending from the siding ~ 2 ft long and 8 ft east of the stairs

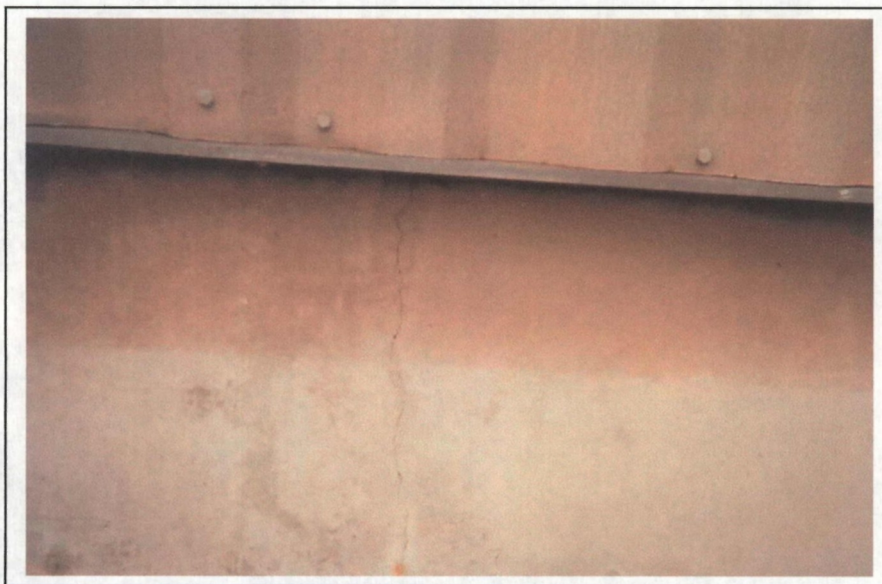
Photo Id: No. 11

Vertical hairline crack extending from the siding ~ 2 ft long and 12 ft east of the stairs

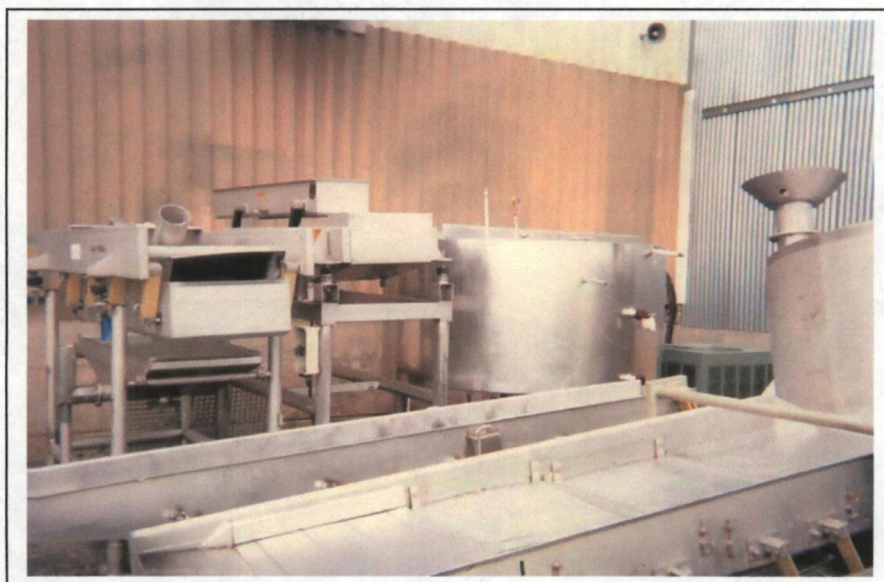
Photo Id: No. 12

Obstructions near the west of the addition

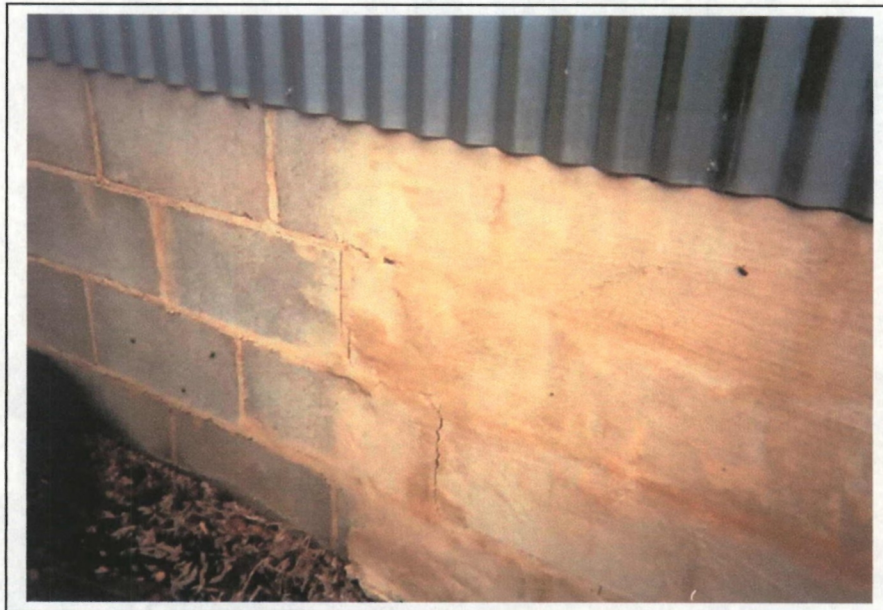
Photo Id: No. 13

Step crack in concrete of addition (west face)

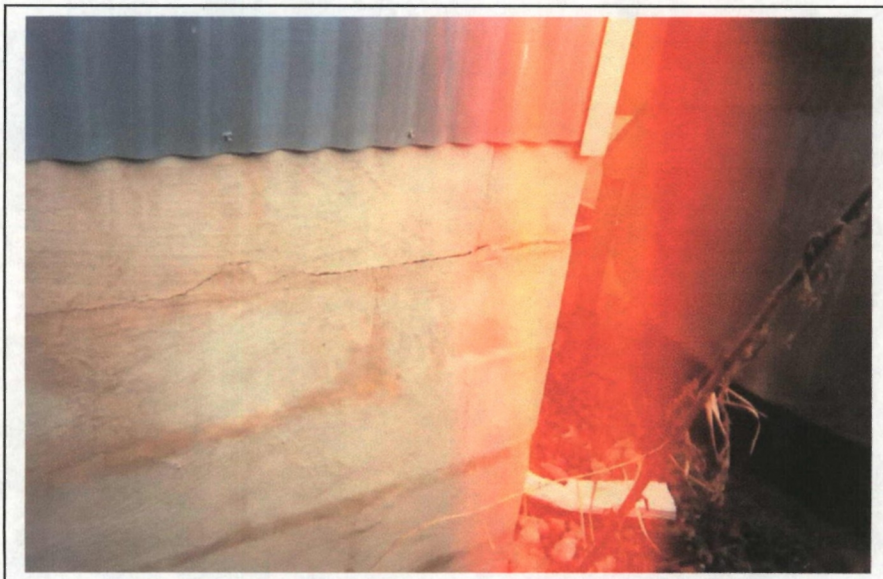
Photo Id: No. 14

Horizontal mortar joint crack ~ 2 ft long. Also 3 vertical hairline cracks ~ 8" long

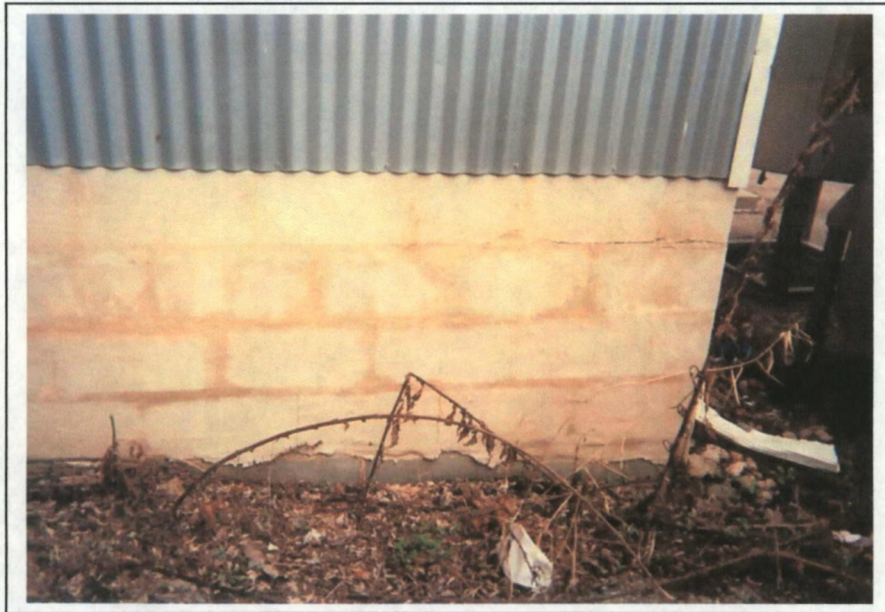
Photo Id: No. 15

Overview of the southwest corner of the addition showing various vertical and horizontal hairline cracks

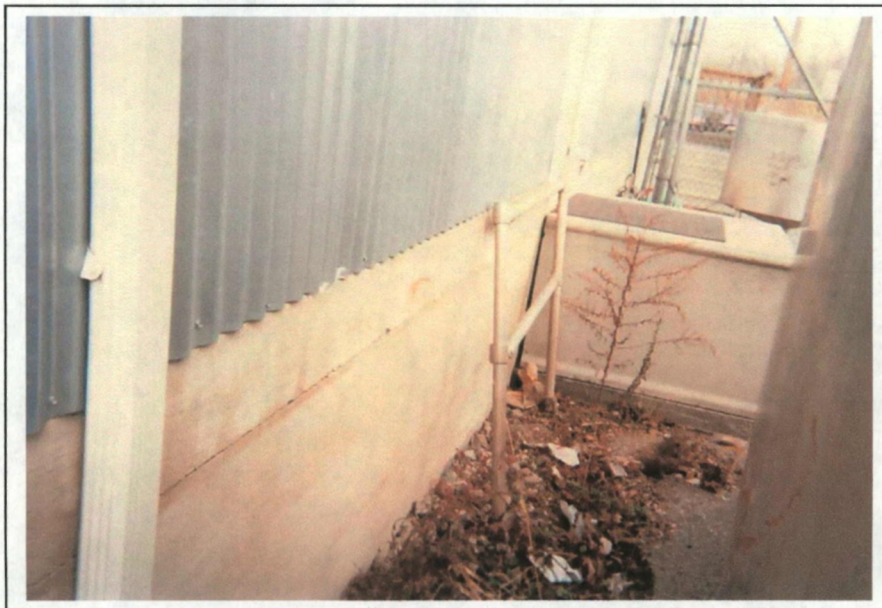
Photo Id: No. 16

Mortar crack in the south face of the addition ~ 10 ft long

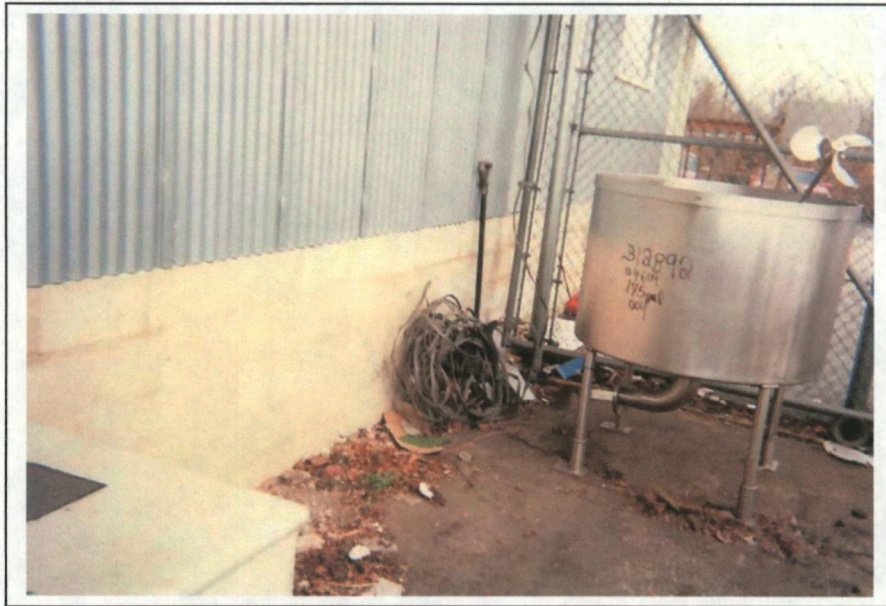
Photo Id: No. 17

Mortar crack in the south face of the addition extending the rest of the way across

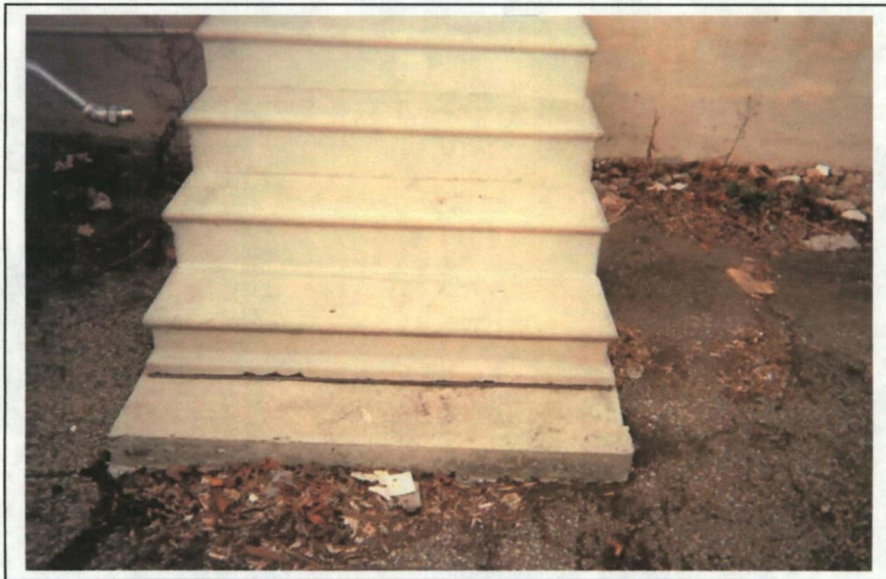
Photo Id: No. 18

Joint separation between concrete slab and stairs

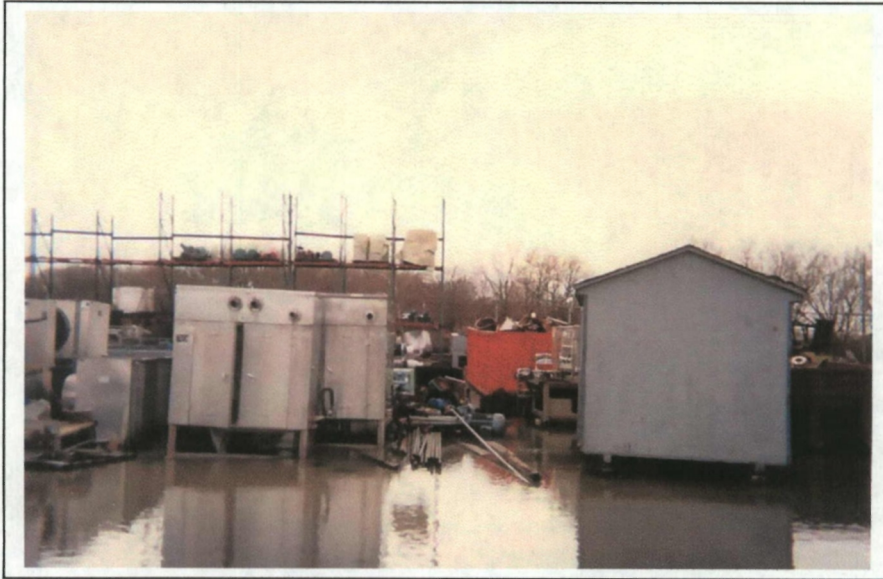
Photo Id: No. 19
Date 3/14/01

Unstable structures in the lot (west side near retaining wall)

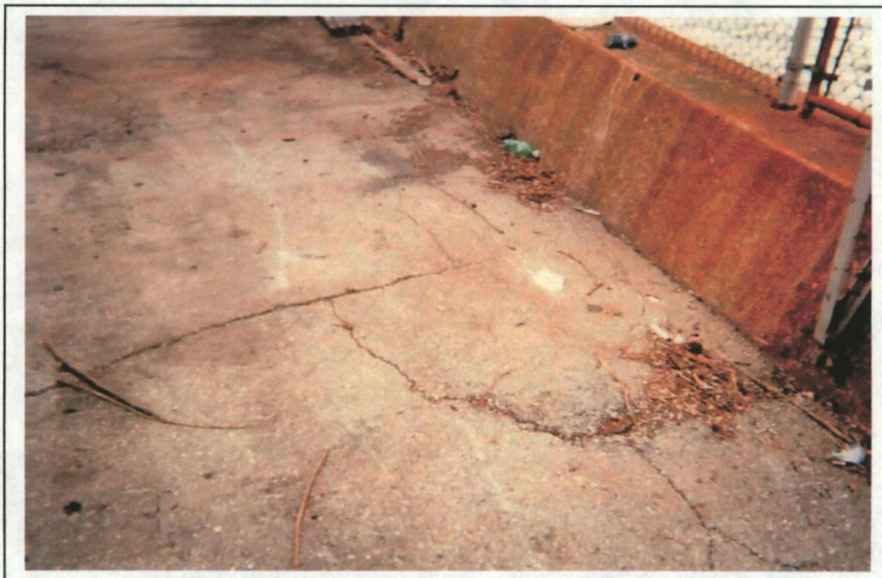
Photo Id: No. 20
Date 3/14/01

Asphalt cracks at seismograph location #3

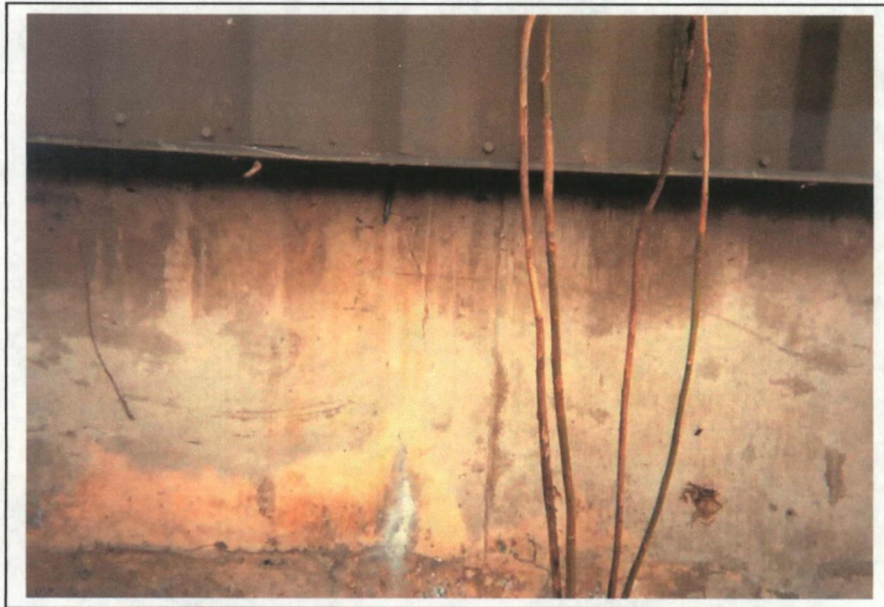
Photo Id: No. 21

Vertical hairline crack ~2' long extending from the siding on the west face of the warehouse, 20 ft from the southwest corner (obstructed during pre-construction survey)

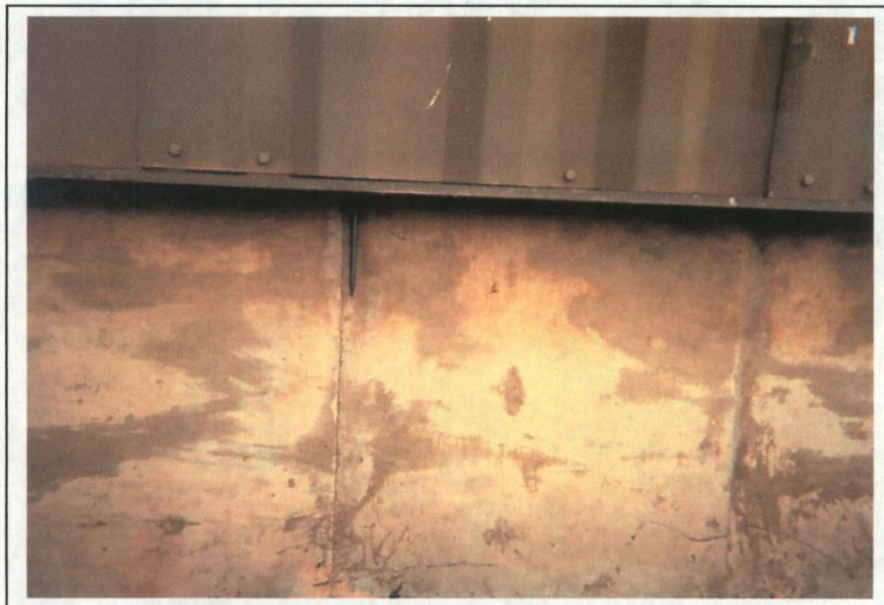
Photo Id: No. 22

Vertical separation extending from the siding on the west face of the warehouse, 28 ft from the southwest corner (obstructed during pre-construction survey)
